YOUR INSPECTION REPORT

12345 Cranbrook Street
Cranbrook, BC

Thursday, January 5, 2023

Out
Of
The
Woods

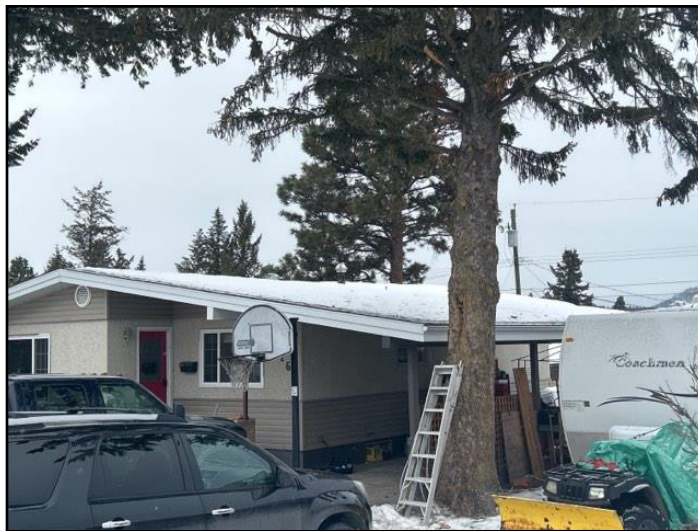
- The visual inspection of the roof was limited by snow cover. The buyer is advised that the roof was not visible on the day of inspection and therefore it was not inspected. I recommend having the roof and it's associated systems inspected by a qualified professional once visible, to ensure that there are no issues or deficiencies.

Snow covered

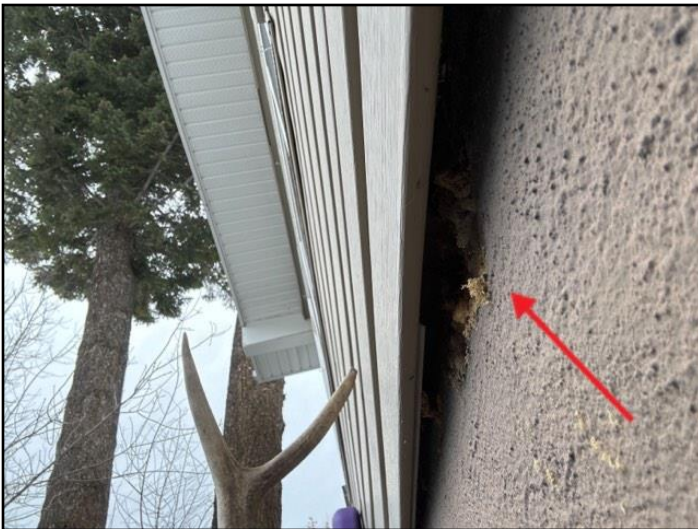
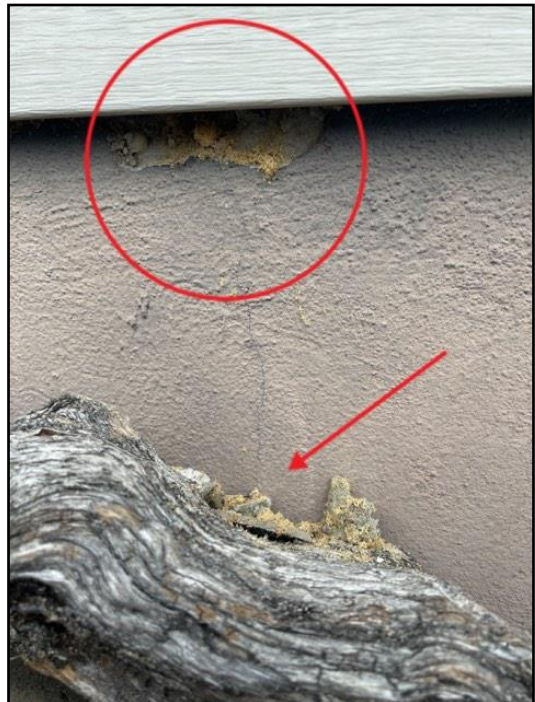
Condition: • Damage

Potential pest damage noted under siding.

Damage

Task: Further investigation required by contractor to determine damage and proper repair.

Time: Immediately upon possession

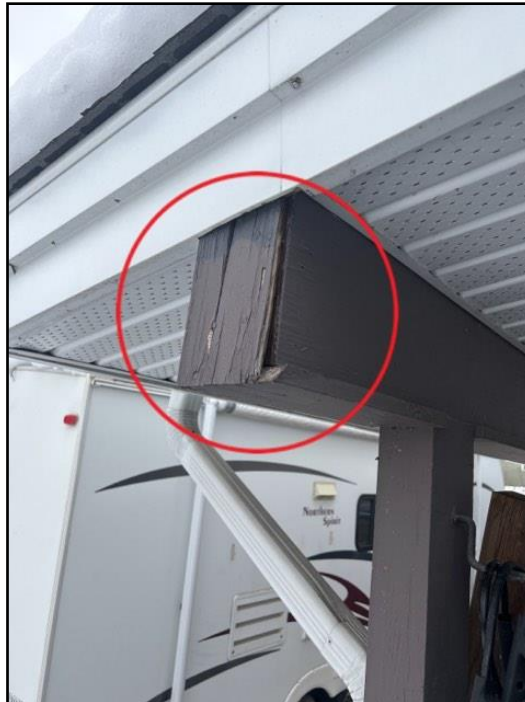
Condition: • Paint - deteriorated / missing

Paint missing, and minor deterioration on end of beam

Paint - deteriorated / missing

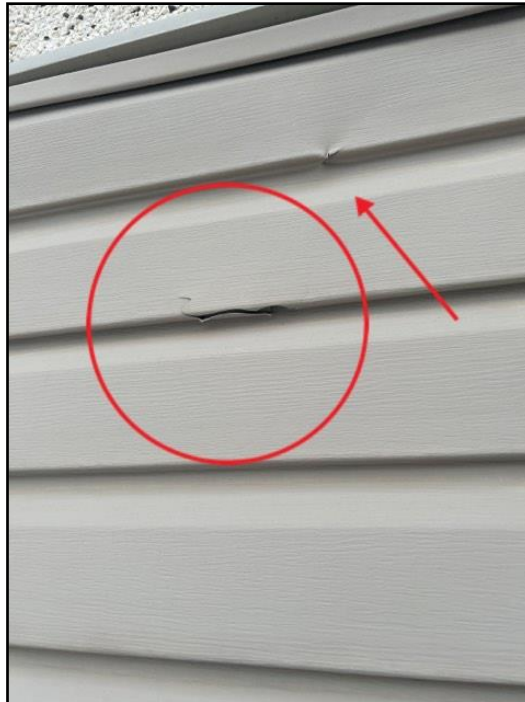
WALLS \ Vinyl siding

Condition: • [Mechanical damage](#)

Implication(s): Chance of water damage to structure, finishes and contents

Mechanical damage

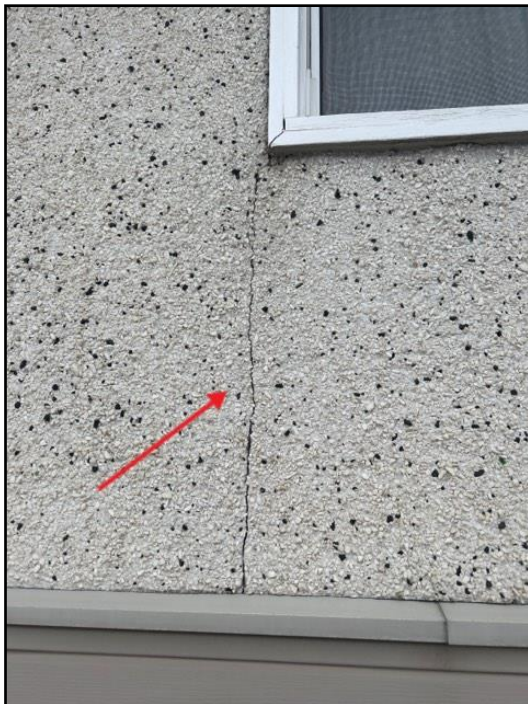
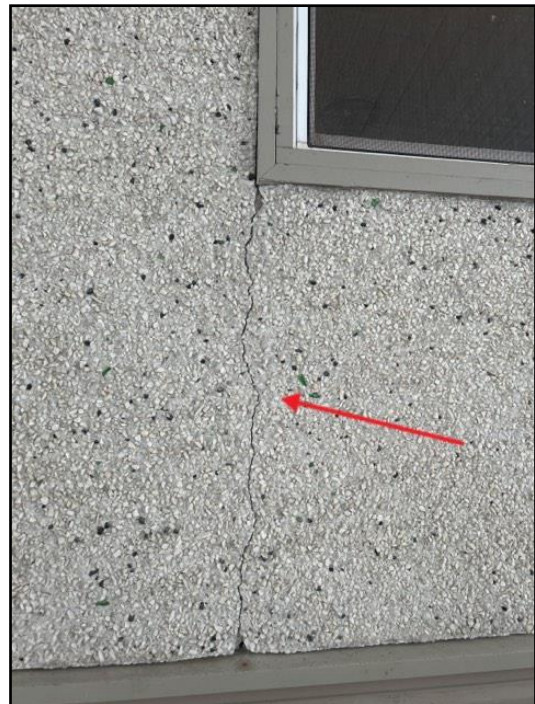
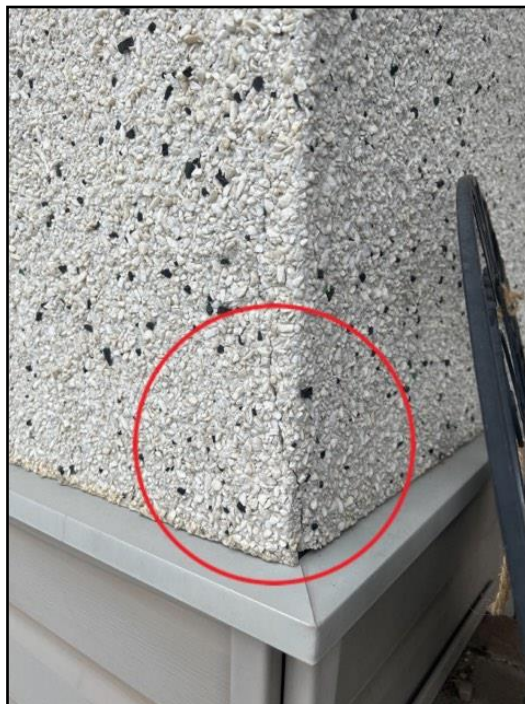
Condition: • Minor cracks

Minor exterior cracks noted

Implication(s): Shortened life expectancy of material. Chance of water damage to structure, finishes and contents, Material deterioration

Minor cracks

Task: Seal all exterior cracks

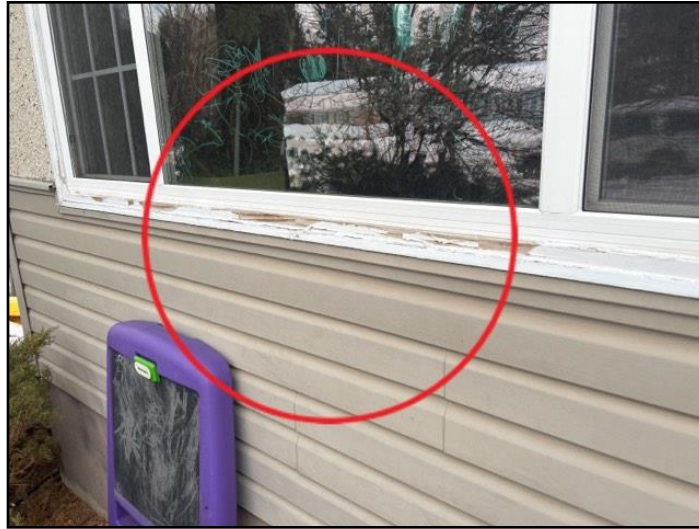
Condition: • [Paint or stain needed](#)

Implication(s): Chance of water damage to structure, finishes and contents | Material deterioration

Paint needed

Task: Repaint

Time: Regular maintenance

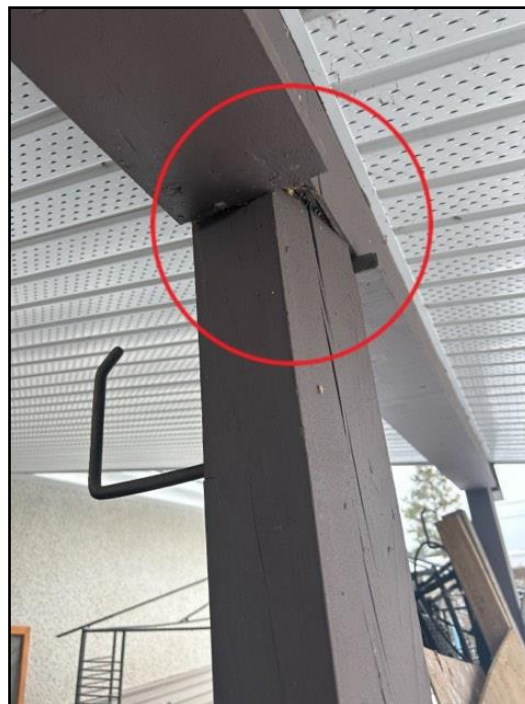
Condition: • Twisted post noted

Twisted post

Task: Replace twisted post to ensure proper bearing

Time: As soon as practical

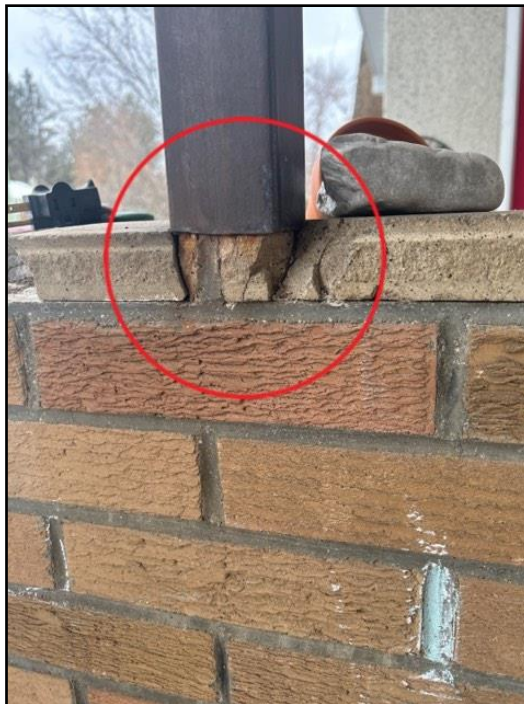
Condition: • Cracking noted in bricks where metal post is bearing.

Cracked bricks

Task: Monitor monthly for movement. If ongoing movement is noted engage contractor to further investigate and determine scope and cost of repair.

Time: Ongoing upon possession

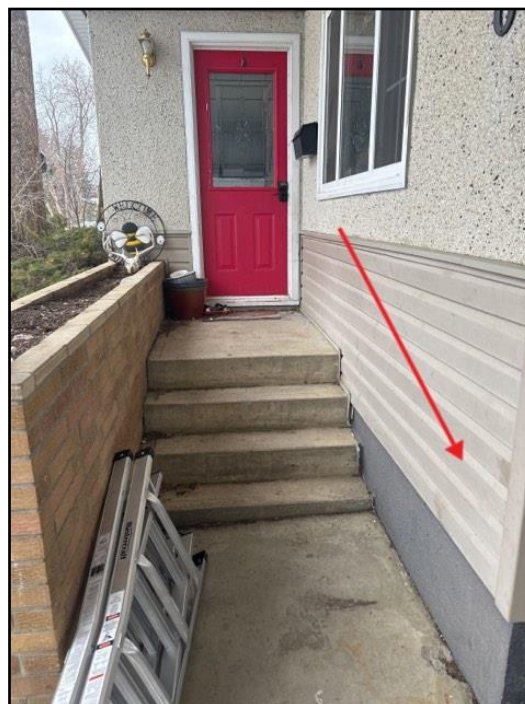
Condition: • [Missing](#)

Implication(s): Fall hazard

Missing handrail

Task: Install handrail

Time: Upon possession

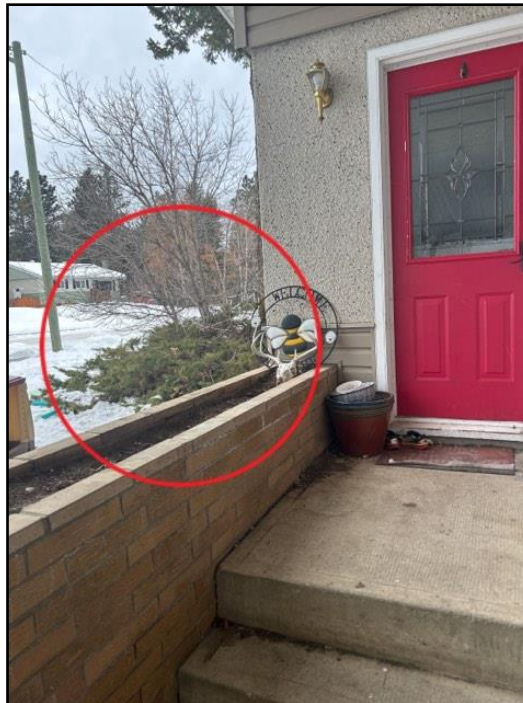
Condition: • [Missing](#)

Missing guard rail noted on front entryway

Implication(s): Fall hazard

Missing guard rail

Task: Install guard rail

Time: Upon possession

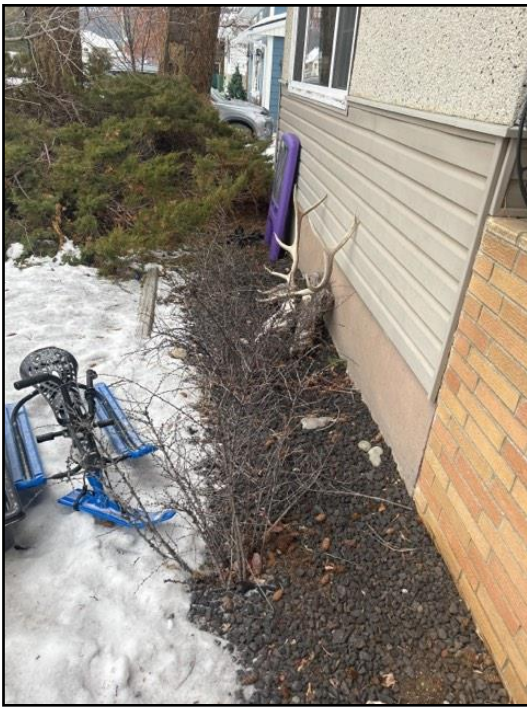
Condition: • [Planters and gardens against walls](#)

Flower bed noted against foundation

Implication(s): Chance of water entering building | Chance of damage to structure | Chance of structural movement

Flower bed against foundation

Task: Remove flower bed or move flower bed away from exterior foundation. wall

Time: Upon possession

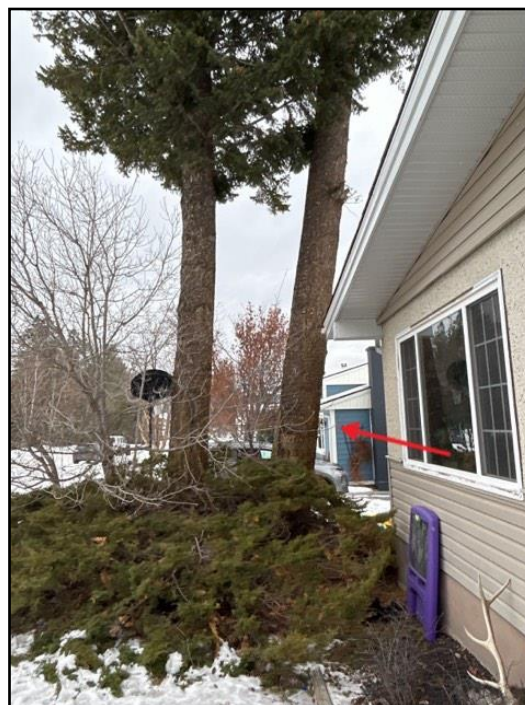
Condition: • [Trees or shrubs too close to building](#)

Large trees noted at front of home

Implication(s): Chance of water damage to structure, finishes and contents | Chance of pests entering building | Material deterioration

Trees too close to building

Time: As soon as possible upon possession

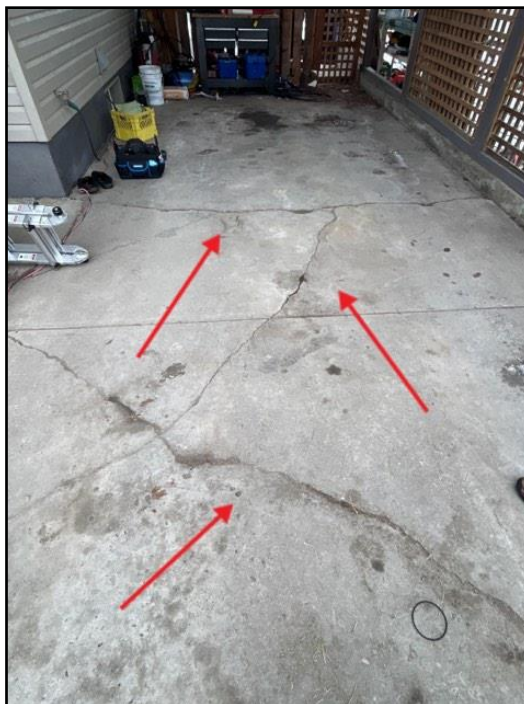
Condition: • Cracked or damaged surfaces

Implication(s): Open cracks in the driveway allow water to enter and freeze. This may cause further damage or lifting to the driveway creating a tripping hazard.

Cracked surfaces

Task: Seal cracks to prevent water ingress and further damage from freeze/thaw cycles. Monitor for ongoing movement. If movement continues replacement may be necessary.

Time: Ongoing

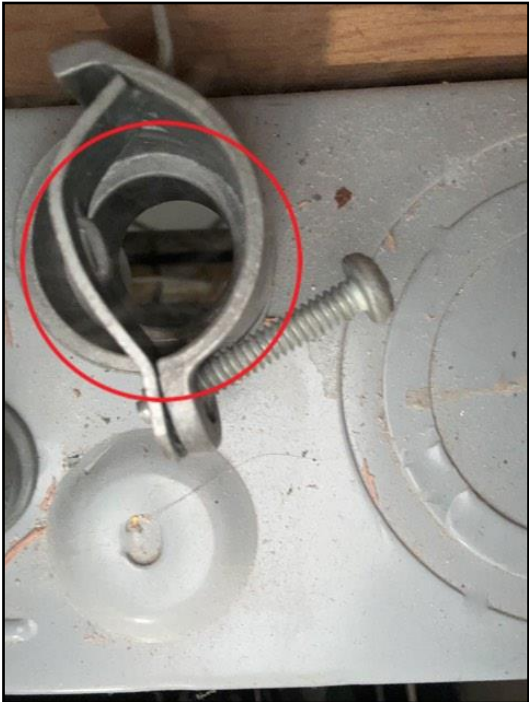
Condition: • [Unprotected openings](#)

Unprotected opening noted in distribution box

Unprotected openings

Task: Repair

Time: Immediately upon possession

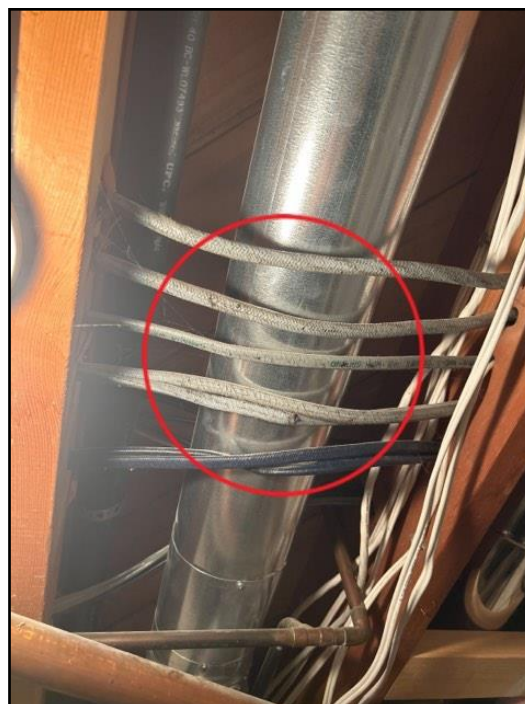
Condition: • [Too close to/touching ducts, pipe, chimneys, etc.](#)

Implication(s): Electric shock | Fire hazard

Wires touching ducts

Task: Improve

Time: Immediately upon possession

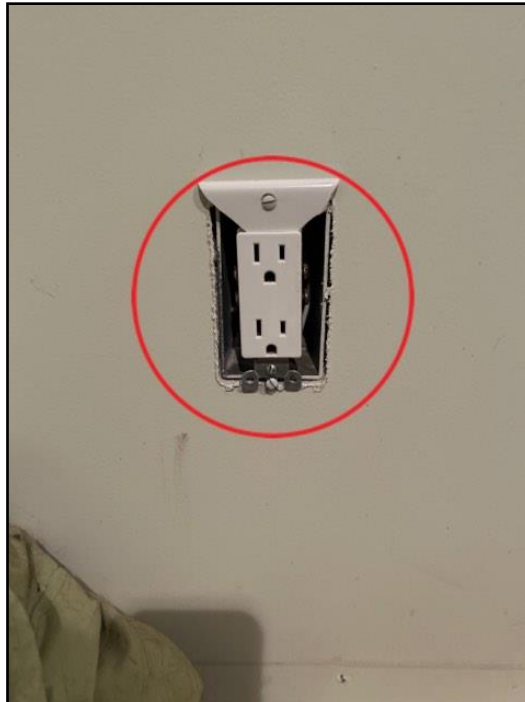
Condition: • [Damage](#)

Damaged face plate noted

Implication(s): Electric shock | Fire hazard

Damage

Task: Replace

Time: Immediately upon possession

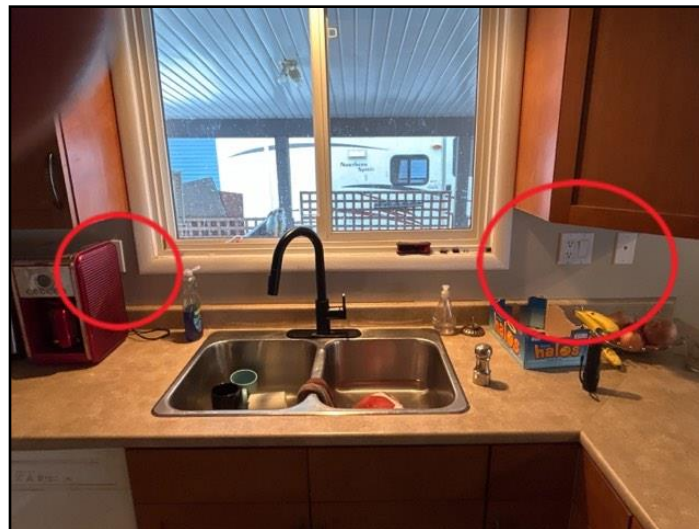
Condition: • Kitchen counters

GFCI plugs missing

Task: Recommend improvement and installing GFCI receptacles

Time: Immediately upon possession

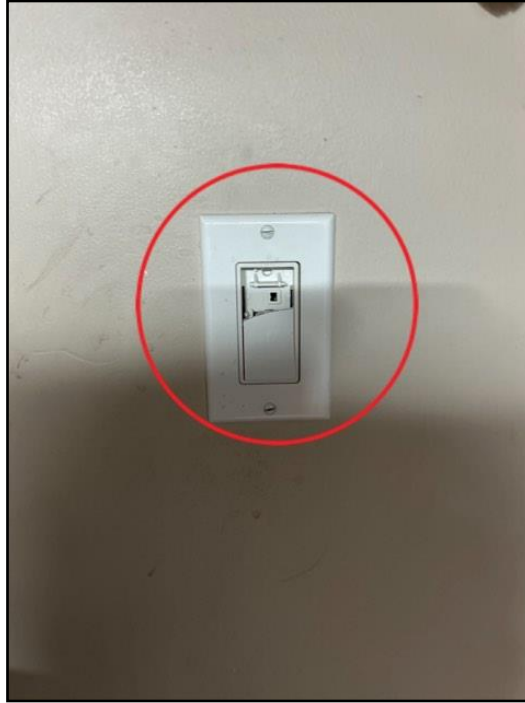
Condition: • [Damage](#)

Implication(s): Electric shock | Fire hazard

Damage

Task: Repair

Time: Immediately upon possession

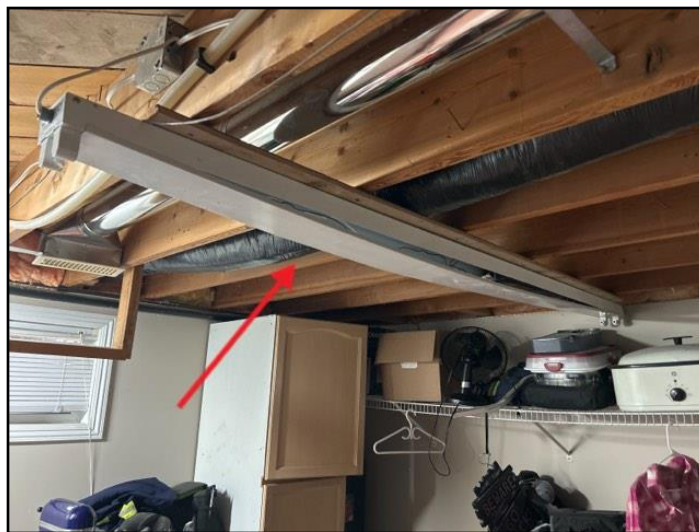
Condition: • [Inoperative](#)

No bulbs and fluorescent light. Damage on fixture also noted.

Implication(s): Inadequate lighting

Inoperative

Task: Repair

Time: Upon possession

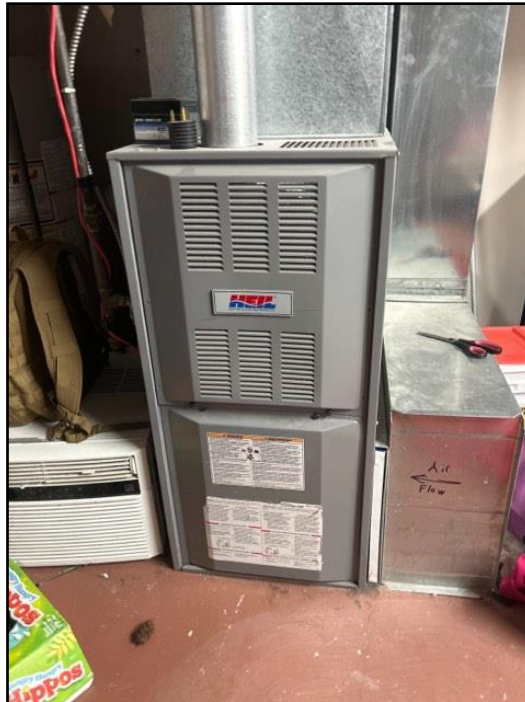
Condition: • [Near end of life expectancy](#)

Implication(s): Equipment failure | No heat for building

Near end of life expectancy

Task: Engage heating specialist to determine scope and cost of replacement. Anticipate replacement and budget accordingly.

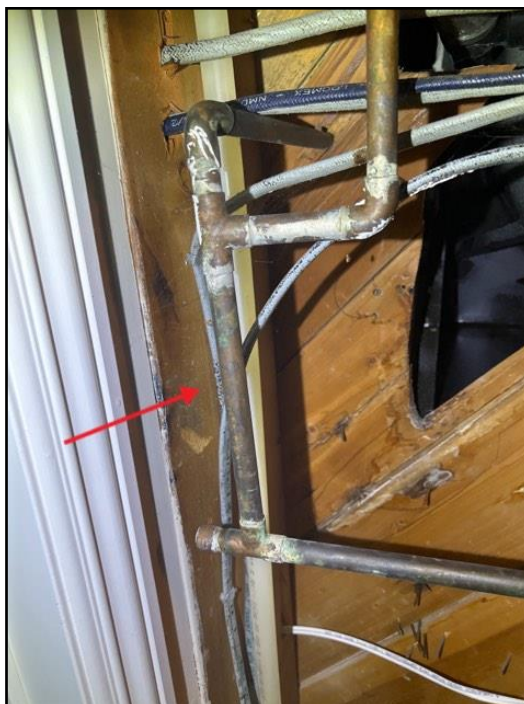
Condition: • Copper pipes generally have a life expectancy of 50 years. These pipes appear to be the original to the home, and therefore are nearing or at their expected life.

Old copper pipes

Task: Monitor monthly for leaks, should you see any signs of corrosion, drips, or leaks, immediately contact a plumber to repair.

Time: Regular maintenance and inspection required

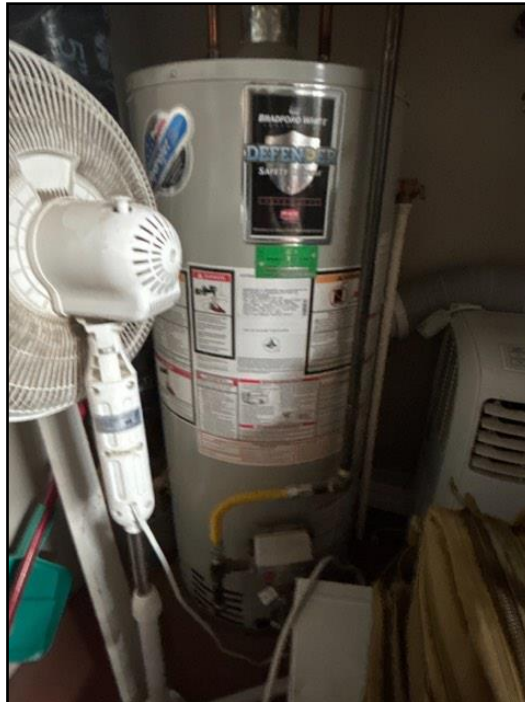
Condition: • [Near end of life expectancy](#)

Near end of life expectancy

Task: Engage insurance provider. Engage plumbing contractor to determine cost and scope of replacement. Budget for replacement.

Time: Before subject removal

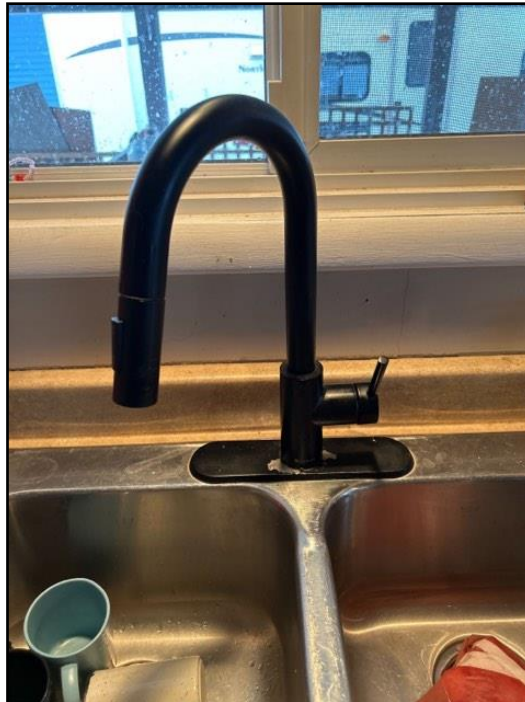
Condition: • [Loose](#)

Loose Fossett noted

Implication(s): Equipment failure

Loose

Task: Repair

Time: Upon possession

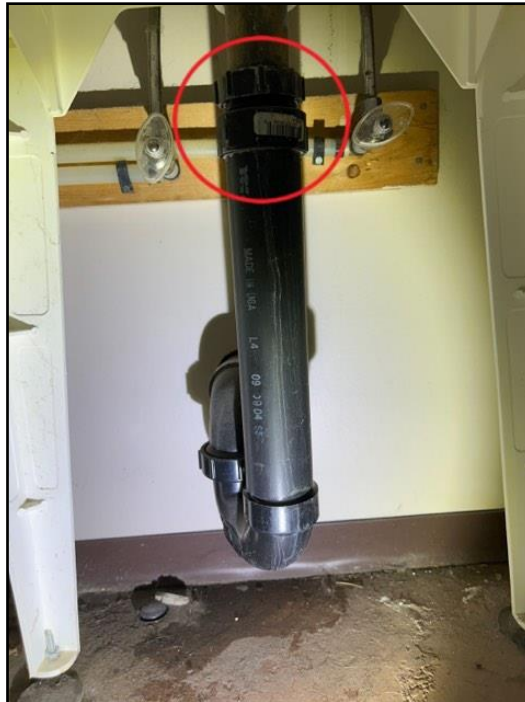
Condition: • Leak

Leak noted on drain

Implication(s): Chance of water damage to structure, finishes and contents

Leak

Task: Repair

Time: Before use

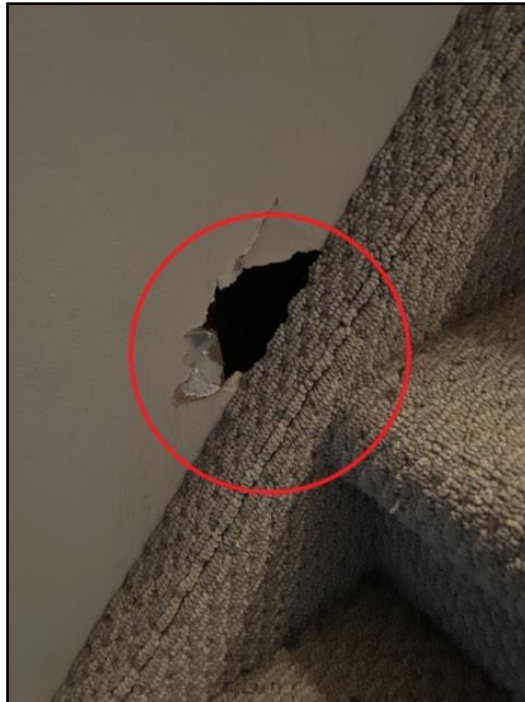
Condition: • Damaged

Minor damage noted

Implication(s): Cosmetic damage

Damaged

Task: Repair

Time: Regular maintenance

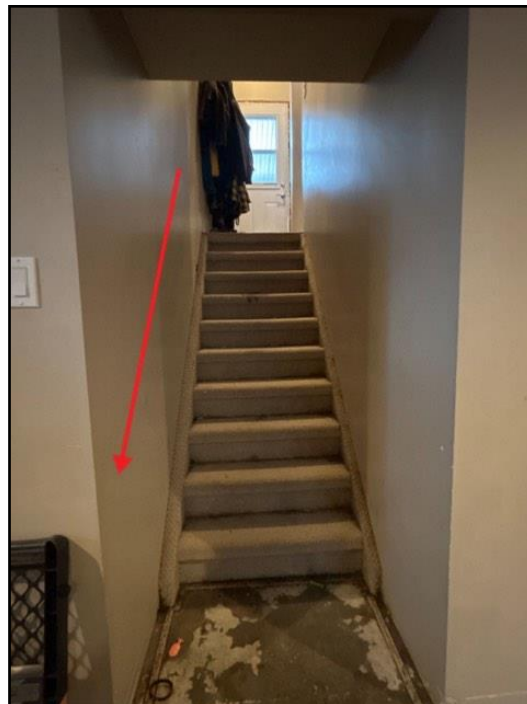
Condition: • [Missing](#)

Missing handrail noted

Implication(s): Fall hazard

Missing

Task: Install handrail

Time: Immediately upon possession
